ARF Rebuild

by
Steve Steinbring

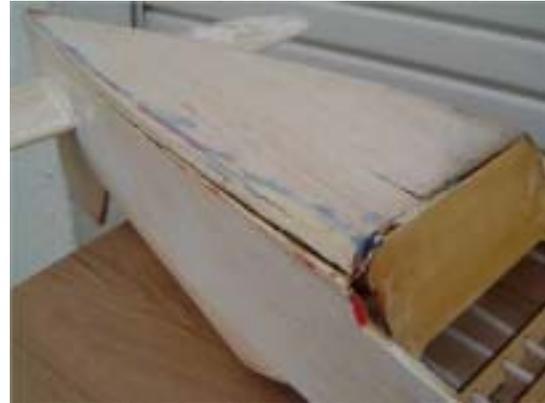
The tail area of the fuselage had a number of fractures, some of the internal bulkheads were also separated in need of repair and gluing.

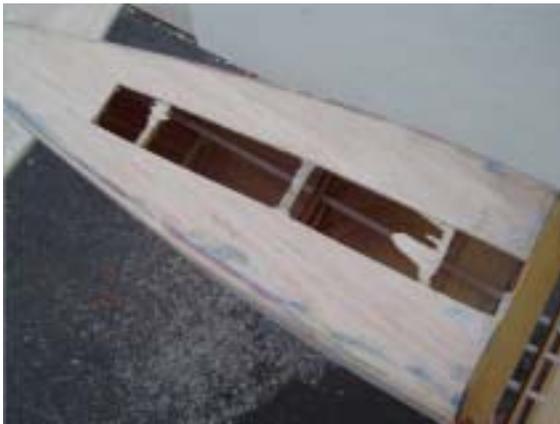
This shot shows some of the damage to the cockpit area and the right side of the fuselage.

A hatch was cut in the bottom of the fuselage to allow access to bulkheads and sheeting that needed repair and gluing. Broken bulkheads were sistered with scrap balsa and glued with non-sag Epo-Grip #30 Paste epoxy to the sheeting.
