# Cowling Repair

Cowling repairs are made easy with Epo-Grip Adhesives!

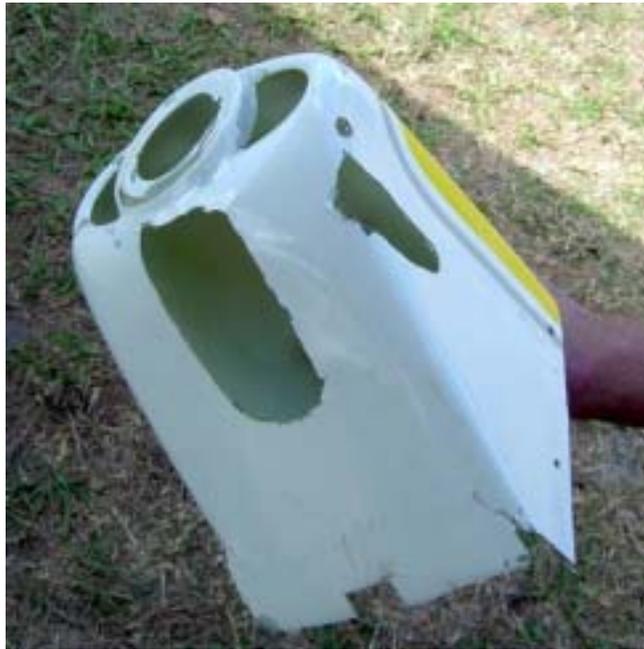
Here is a cowling from an Ultimate 40 Bipe in need of repair, salvaged from a trashcan with the remainder of the bird for rebuild. Although the cowl is badly damaged from poor venting cuts or crashes it is not all that difficult to repair to serviceable condition.

The first step is to thoroughly degrease and sand the cowling before attempting any repairs.

The second step is to stop drill any cracks to prevent further running into the cowl.

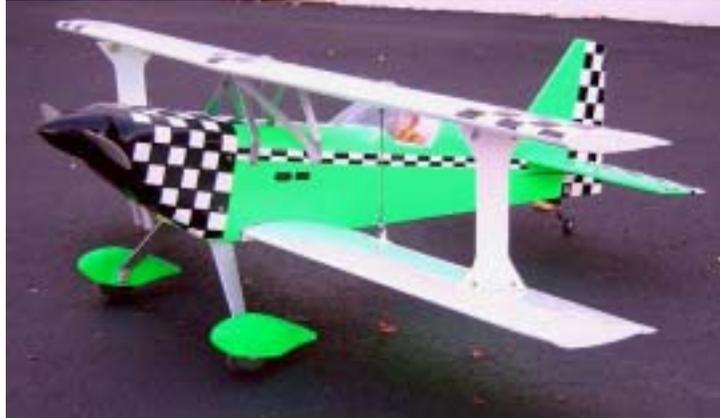
Below is the finished cowl back on the bird!

After you have the cowling openings replaced to your satisfaction its time to sand and prime making the cowl ready for paint. Use auto body glazing putty for removing any final flaws before final priming and paint.
